Refinery LPS Bulletin – Reliability

F-8007 Flame-out

**Location: Pascagoula
Reformatte Splitter Unit
(RSU) - 80 Plant**

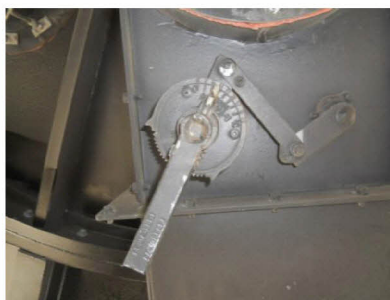
Burner inlet air register handle

- 1) Stop work authority was not exercised when it was realized that the appropriate F-8007 start up procedure was not posted to the web.
- 2) Miscommunication between inside and outside Operators resulted in the inlet air register being closed too far causing flame out.
- 3) The priority of environmental alarms relative to safety alarms during startup was not understood. Adjusting the furnace to meet the new refinery NOX regulations is inconsistent with safe operation of the furnace during start up.
- 4) Training on new burners was inadequate.

- 1) Emphasize Stop Work Authority expectations.
- 2) Review this bulletin with furnace Operators, project personnel and personnel involved in signing off on PSSR to share learnings.
- 3) See complete incident investigation report for all detailed findings and recommendations (attached in IMPACT ERM LI# 8391)

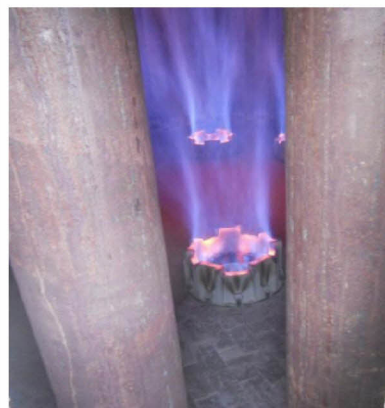
Burners – normal operation
